**Safety Alert**

**Airway Compromise and Pre-Hospital Nasal Pharyngeal Airway**

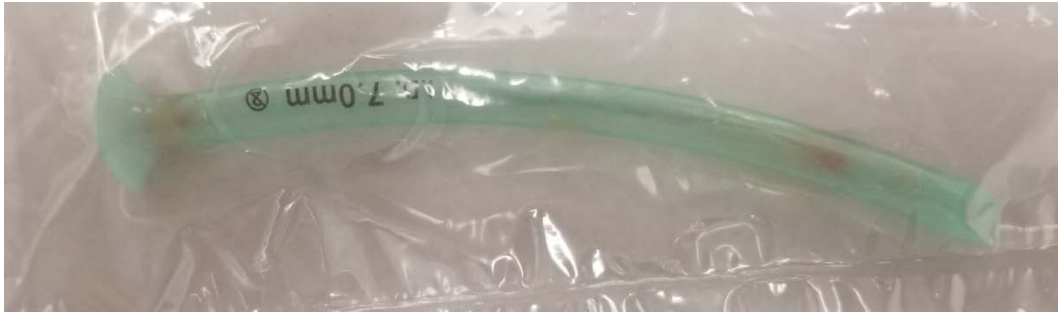
<b>S</b>	<p><b>SITUATION</b></p> <p>Two hospitals have reported patient safety events related to the dislocation of the nasal pharyngeal airway pictured above. Post intubation at the hospital, it was discovered via X-ray that the airway had displaced into the bronchus of a patient. Other incidences included discovery of this nasal pharyngeal airway deep in the oropharynx during diagnostic and hospital intubation procedures.</p>
<b>B</b>	<p><b>BACKGROUND</b></p> <ul style="list-style-type: none"> <li>• This product is not an inventory item for Sentara Hospitals; however, in these incidences, the patient was transported to the hospital via EMS services.</li> <li>• Unable to determine manufacturer or distributor of this airway.</li> <li>• This product has a small, pliable flange that can slip through the patient’s nares into the lower airway causing major airway obstruction.</li> </ul>
<b>A</b>	<p><b>ASSESSMENT</b></p> <ul style="list-style-type: none"> <li>• This product is prone to dislocating from the nasal pharyngeal airways to the oropharynx and lower airways.</li> <li>• This product is not radiopaque making radiology confirmation difficult.</li> </ul>

<b>R</b>	<p><b>RECOMMENDATION</b></p> <ul style="list-style-type: none"> <li>• Interface with the local EMS organizations and Medical Directors to communicate incidences and to have item removed from inventory.</li> <li>• On-going efforts to identify manufacturer of product.</li> <li>• Increase awareness of possible dislocation of nasal pharyngeal airway.</li> </ul>
